COMPLIANCE ASBESTOS RE-INSPECTION AND RISK ASSESSMENT

JULY 2023

J053219

C110666 Christian Brothers College

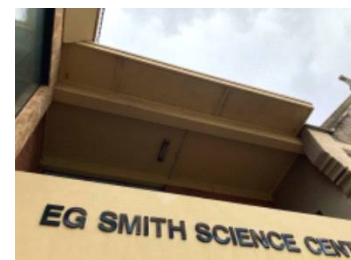
Location		EG Smith Building - Level 2 - Exterior - Northern Balcony - Ceiling & Eave Lining - Fibre Cement Sheeting									
Hazard Type		Asbestos		Material Assessment		Disturbance Assessment					
Friability		Non-friable		Product Type		1 Occupancy		0			
Sample No.		Visual		Extent of damage		0		Disturbance		1	
Result		Assumed Positive Chrysotile		Surface Treatment		1		Exposure		0	
				Asbestos Type		1		Maintenance		0	
Item Number		49		Material Score		3		Disturbance Score		1	
				Priority Score		4		Very Low

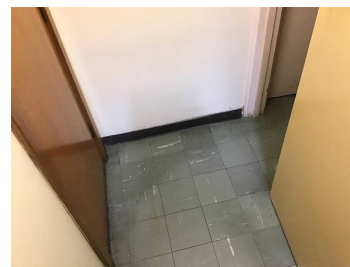
Location		O'Brien Building - Ground Floor - Interior - Female Toilets Rear Of Canteen - Air Lock - Floor Covering - Vinyl Tiles			
Hazard Type	Asbestos	Material Assessment		Disturbance Assessment	
Friability	Non-friable	Product Type	1	Occupancy	0
Sample No.	PB - 35028 {GJ}*	Extent of damage	0	Disturbance	1
Result	Positive Chrysotile	Surface Treatment	0	Exposure	2
		Asbestos Type	1	Maintenance	0
Item Number	9	Material Score	2	Disturbance Score	3
		Priority Score	5	Very Low

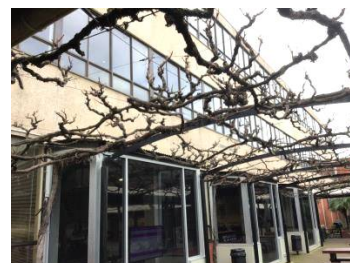
Location		O'Brien Building - All Levels - Interior/Exterior - All Elevations - Window Beading - Mastic Sealant			
Hazard Type	Asbestos	Material Assessment		Disturbance Assessment	
Friability	Non-friable	Product Type	1	Occupancy	1
Sample No.	2016-3 {TPS000138}	Extent of damage	0	Disturbance	1
Result	Positive Chrysotile	Surface Treatment	0	Exposure	1
		Asbestos Type	1	Maintenance	0
Item Number	46	Material Score	2	Disturbance Score	3
		Priority Score	5	Very Low
