COMPLIANCE ASBESTOS RE-INSPECTION AND RISK ASSESSMENT

SEPTEMBER 2021

J032704

C100202 Christian Brothers College Early Learning Centre

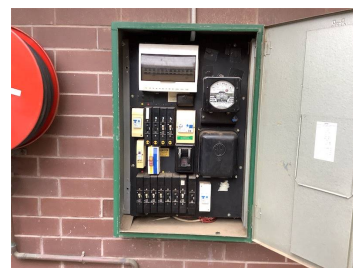
| Location | Main Building - Ground Floor - Exterior - Electrical - Switch Board - Compressed Bituminous Electrical Panel - West Elevation | | |
| Result | Assumed Positive Chrysotile | Surface Treatment | Exposure |
| | | Priority Score | Very Low |

| Item No | Location / Description | Hazard Type | Sample No. | Item Status | Est. Extent | Current Label | Condition | Friability | Disturbance Risk | Material Risk | Control Priority | Recommended Action | Record of Works |
|---|---|---|---|---|---|---|---|---|---|---|---|---|--|
| | Electrical - Switch Board - Compressed Bituminous Electrical Panel | Asbestos | Visual | Assumed, Positive | 1no. | Yes | Good Condition | Non-friable | Very Low | Very Low | P4 | Manage In Situ | No Change |

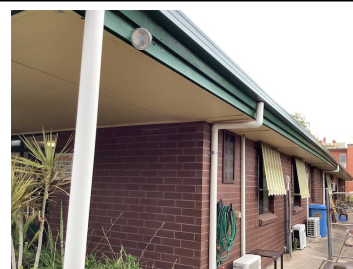
| Location | Main Building - Ground Floor - Exterior - Eaves - Fibre Cement Sheetting - All Elevations | | |
| Result | Assumed Positive Chrysotile | Surface Treatment | Exposure |
| | | Priority Score | Very Low |

| Item No | Location / Description | Hazard Type | Sample No. | Item Status | Est. Extent | Current Label | Condition | Friability | Disturbance Risk | Material Risk | Control Priority | Recommended Action | Record of Works |
|---|---|---|---|---|---|---|---|---|---|---|---|---|--|
| | Eaves - Fibre Cement Sheeting | Asbestos | Visual | Assumed, Positive | 30m ² | No | Good Condition | Non-friable | Very Low | Very Low | P4 | Label & Manage In Situ | No Change |

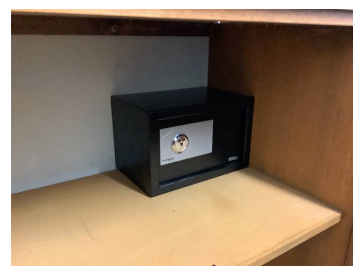
| Location | Main Building - Ground Floor - Interior - Front Office - Safe - Millboard Insulation - Adjacent Foyer | | |
| Result | Assumed Positive Chrysotile | Surface Treatment | Exposure |
| | | Priority Score | Very Low |

| Item No | Location / Description | Hazard Type | Sample No. | Item Status | Est. Extent | Current Label | Condition | Friability | Disturbance Risk | Material Risk | Control Priority | Recommended Action | Record of Works |
|---|---|---|---|---|---|---|---|---|---|---|---|---|--|
| | Safe - Millboard Insulation | Asbestos | Visual | Assumed, Positive | 1no. | No | Good Condition | Friable | Very Low | Low | P4 | Label & Manage In Situ | No Change |

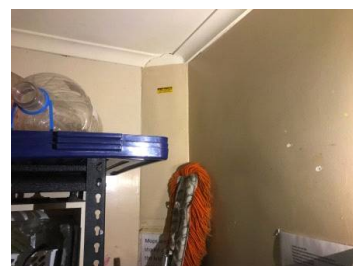
| Location | Main Building - Ground Floor - Interior - Store - Cleaner's Room - Wall Angled Infill Panel - Fibre Cement Sheetting - Corner above Sink | | |
| Result | Assumed Positive Chrysotile | Surface Treatment | Exposure |
| | | Priority Score | Very Low |

| Item No | Location / Description | Hazard Type | Sample No. | Item Status | Est. Extent | Current Label | Condition | Friability | Disturbance Risk | Material Risk | Control Priority | Recommended Action | Record of Works |
|---|---|---|---|---|---|---|---|---|---|---|---|---|--|
| | Wall Angled Infill Panel - Fibre Cement Sheeting | Asbestos | Visual | Assumed, Positive | 2m ² | Yes | Good Condition | Non-friable | Very Low | Very Low | P4 | Manage In Situ | No Change |

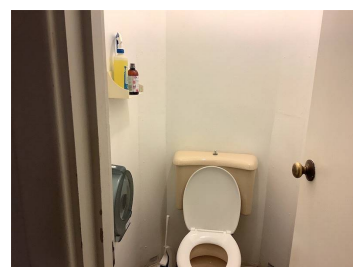
| Location | Main Building - Ground Floor - Interior - Staff Toilets - Angled Infill Panel - Fibre Cement Sheetting - North Wall, Adjacent WC | | |
| Result | Assumed Positive Chrysotile | Surface Treatment | Exposure |
| | | Priority Score | Very Low |

| Item No | Location / Description | Hazard Type | Sample No. | Item Status | Est. Extent | Current Label | Condition | Friability | Disturbance Risk | Material Risk | Control Priority | Recommended Action | Record of Works |
|---|---|---|---|---|---|---|---|---|---|---|---|---|--|
| | Angled Infill Panel - Fibre Cement Sheeting | Asbestos | Visual | Assumed, Positive | 2m ² | Yes | Good Condition | Non-friable | Very Low | Very Low | P4 | Label & Manage In Situ | No Change - Recommend new warning label is installed |

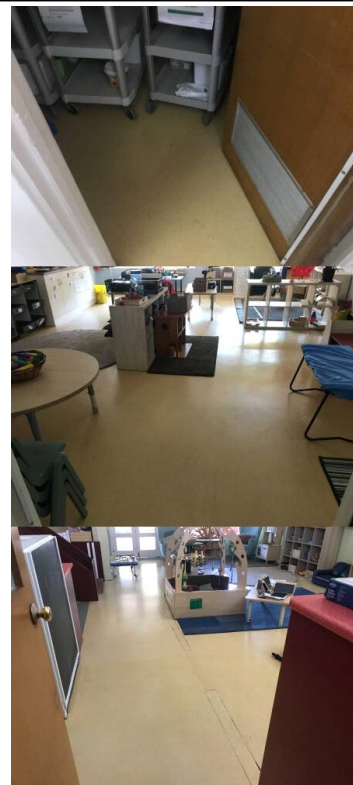
| Location | | Main Building - Ground Floor - Interior - Various Rooms - Floor Covering - Fibrous Backed Sheet Vinyl - Refer Site Plan For Extent Of Floor Covering - Underneath Top Layer Of Vinyl Throughout | |
| Result | Positive Chrysotile | Surface Treatment 1 | Exposure 2 |
| Item Number | 7 | Material Score 4 | Disturbance Score 5 |
| | | Priority Score 9 | Low |

| Item No. | Hazard Type | Item Location and Description | Recommendations |
|---|---|---|---|
| Item 7 | Asbestos | Main Building, Ground Floor, Interior - Various Rooms, Underneath Top Layer Of Vinyl Throughout, Floor Covering - Fibrous Backed Sheet Vinyl - Refer Site Plan For Extent Of Floor Covering | Encapsulate / Repair & Manage In Situ Refer marked up floor plan for details |

| Item No | Location / Description | Hazard Type | Sample No. | Item Status | Est. Extent | Current Label | Condition | Friability | Disturbance Risk | Material Risk | Control Priority | Recommended Action | Record of Works |
|---|---|---|---|---|---|---|---|---|---|---|---|---|--|
| | Floor Covering - Fibrous Backed Sheet Vinyl - Refer Site Plan For Extent Of Floor Covering | Asbestos | J152522-3683-2 (GJ)* | Identified, Positive | 350m ² | Yes | Low Damage | Friable | Very Low | Low | P3 | Encapsulate / Repair & Manage In Situ | No Change - Minor damage location noted in Resource Room, recommend seal with durable tape |
